Address of Inspection
659 Front St
Ottawa, ON

Report ID: SAMPLE
Inspected by: Garnett Hamilton

CONFIDENTIAL PROPERTY INSPECTION REPORT

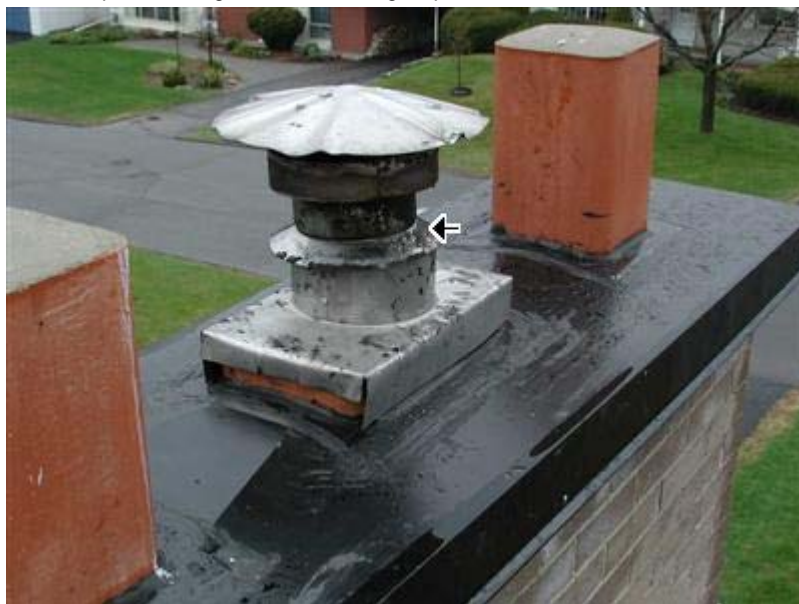
2.5 Picture 1

The cap on the chimney flue for the wood burning fireplace does not look adequate. Recommend further inspection by a WETT certified technician prior to using this wood burning fireplace.

2.5 The cap on the chimney flue for the wood burning fireplace does not look adequate. Recommend further inspection by a WETT certified technician prior to using this wood burning fireplace.

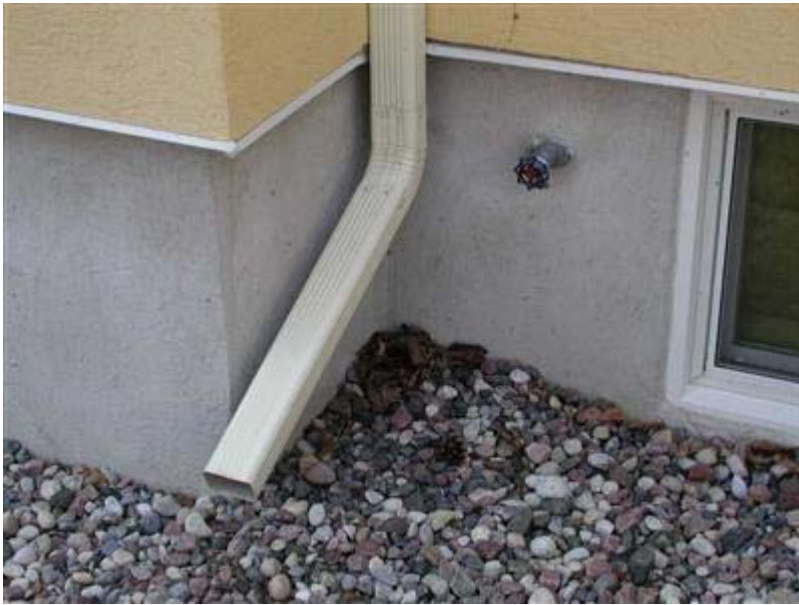
2.6 Picture 1

2.6 Downspout too short on the south east corner. Recommend extending downspout(s) 6 feet (2 m) away from foundation to reduce risk of water penetration into the basement. The grade beyond the downspout should carry the water at least four feet further away from the foundation wall. Please remember that there is a City of Ottawa by-law prohibiting the discharge of rainwater onto adjacent property.

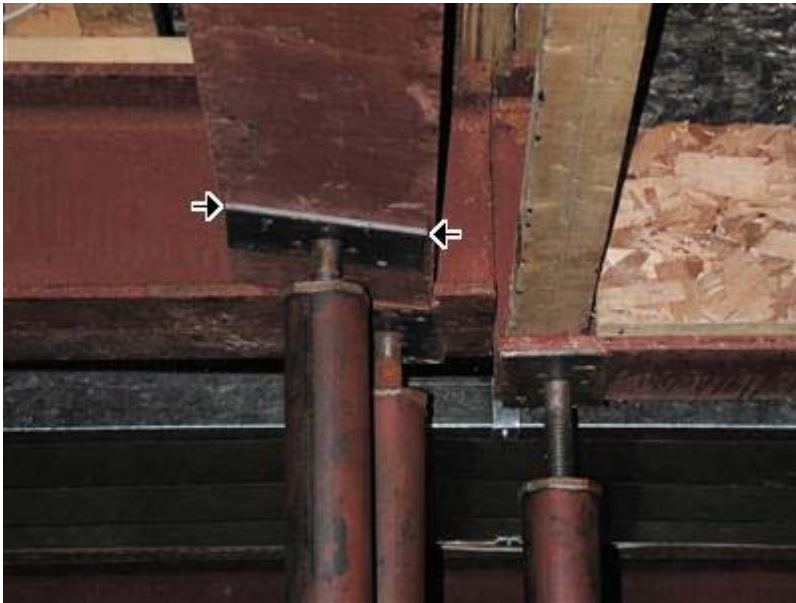
4.2 Picture 1

One steel beam in the basement has twisted on the inside end. The outside end is sitting square in the poured concrete foundation. It appears that this beam has twisted due to non-eccentric loading, i.e., the supported load is not located over the center of the beam. Recommend further review by a qualified structural engineer to determine the remedial action necessary.

4.2 One steel beam in the basement has twisted on the inside end. The outside end is sitting square in the poured concrete foundation. It appears that this beam has twisted due to non-eccentric loading, i.e., the supported load is not located over the center of the beam. Recommend further review by a qualified structural engineer to determine the remedial action necessary.

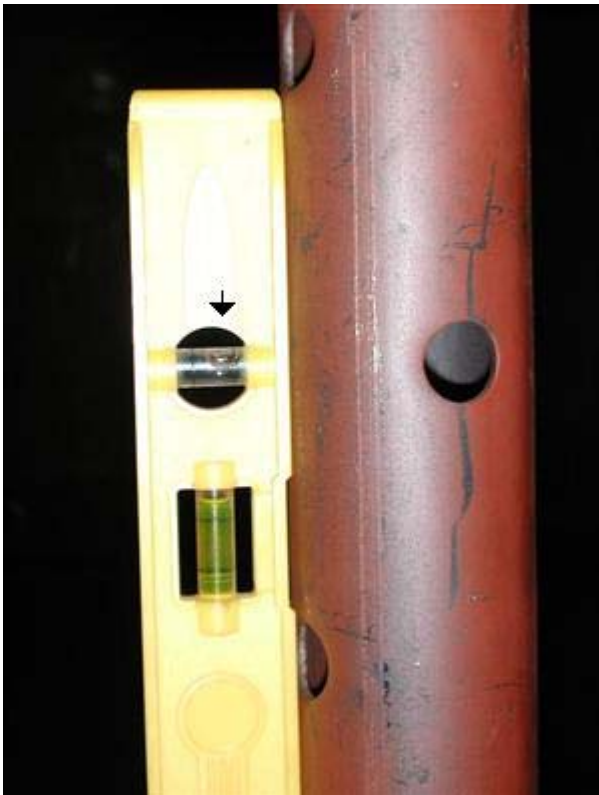
4.3 Picture 1

One steel column is not plumb under the twisted beam in the basement. The top of the column is out of place by approximately two inches. Recommend that this beam and column be securely immediately to prevent movement and possible failure of this building support.

4.3 One steel column is not plumb under the twisted beam in the basement. The top of the column is out of place by approximately two inches. Recommend that this beam and column be securely immediately to prevent movement and possible failure of this building support.

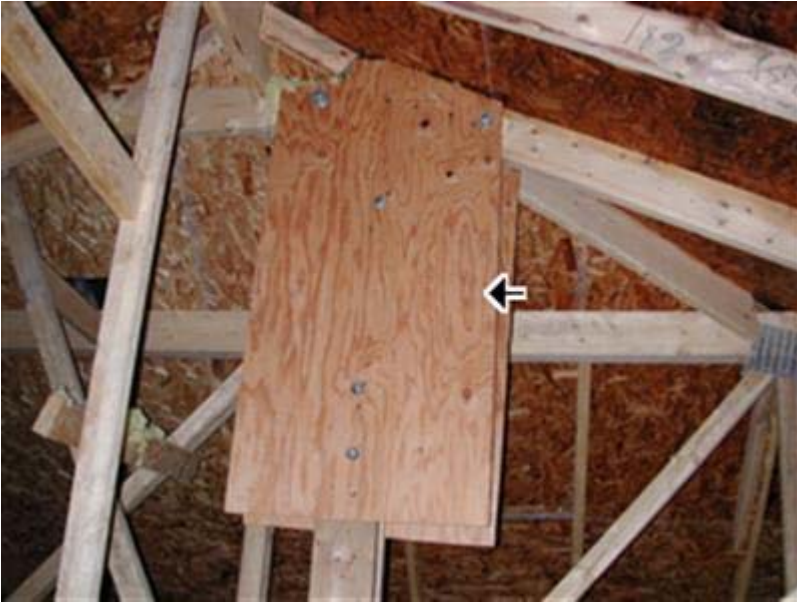
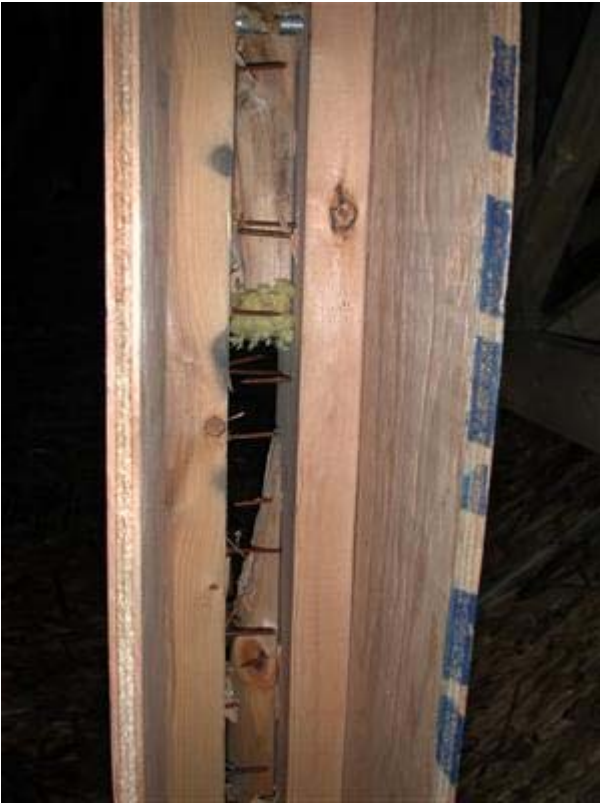
4.7 Picture 1

One of the roof trusses has been modified on-site during construction. While this repair appears solid it does not conform to a typical repair as prescribed by structural engineer. Roof trusses are an engineered product and no changes are permitted without an stamped engineer's drawing. Recommend that the vendor be required to provide proof that this repair was done in accordance with the requirements of a structural engineer.

4.7 One of the roof trusses has been modified on-site during construction. While this repair appears solid it does not conform to a typical repair as prescribed by structural engineer. Roof trusses are an engineered product and no changes are permitted without an stamped engineer's drawing. Recommend that the vendor be required to provide proof that this repair was done in accordance with the requirements of a structural engineer.

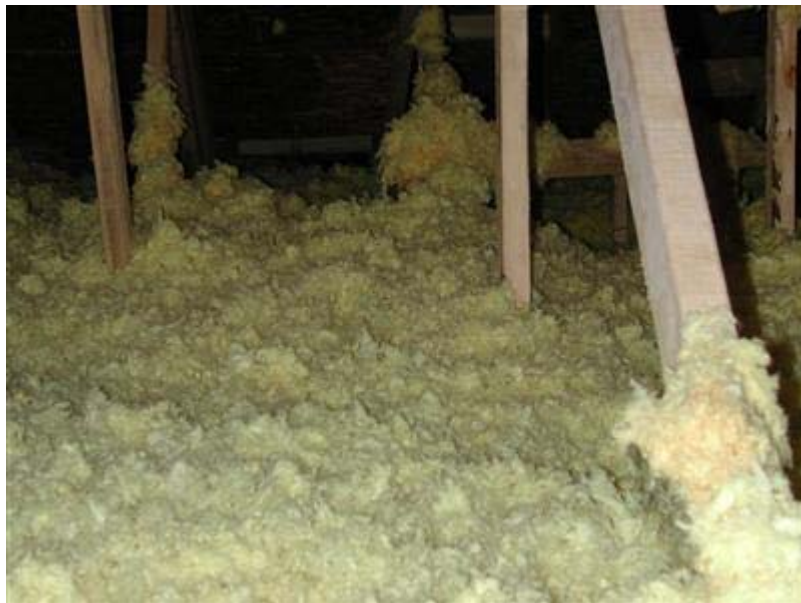
5.0 Picture 1

5.0 Fiberglass (loose-fill) insulation is about twelve inches thick or just under R-38.

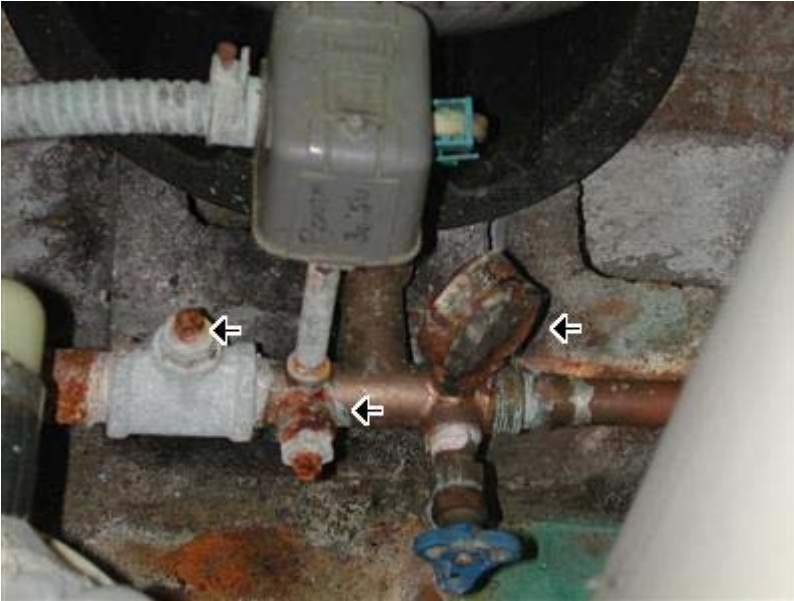
9.1 Picture 1

9.1 Pressure tank is likely to "sweat" in the summer time due to condensation on the cold tank. This leads to rust on the lowest portion of the tank and other metal surfaces that also get wet, as well as water on the basement floor. Recommend insulating the pressure tank to prevent condensation.

The pressure gauge is not working, there is no pressure relief valve and the pressure switch does not have "loss of prime" feature to protect the motor from burning out in the event of low water level. Recommend that a qualified plumber be hired to make the necessary repairs.
